SAPPHIRE REINFORCED ALUMINA MATRIX COMPOSITES

Martha H. Jaskowiak
NASA Lewis Research Center
Cleveland, Ohio

Abstract

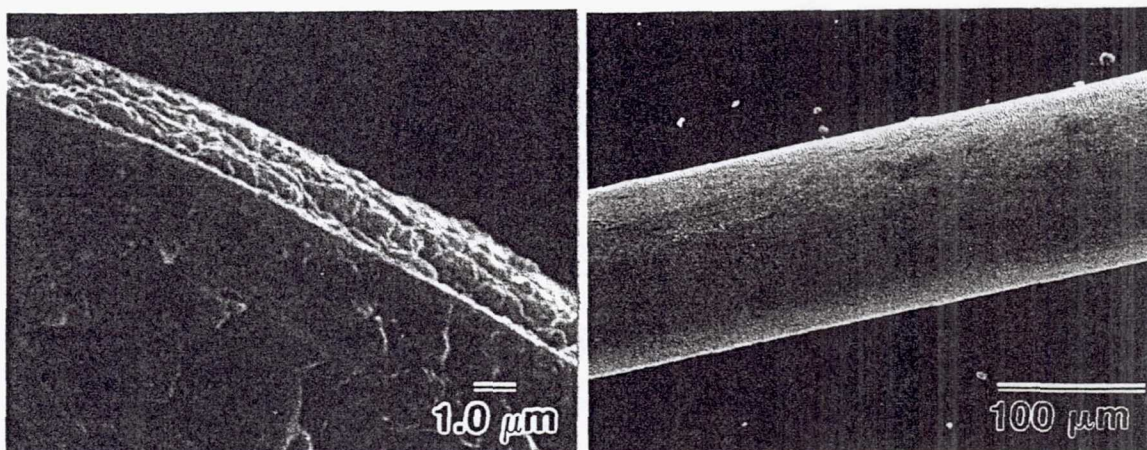
Figure 1. Sol-gel derived ZrO₂ coatings on Saphikon fibers.

Sapphire fibers, produced by Saphikon, Inc. (Milford, NH), were used as reinforcement in the oxide matrix composites. The c-axis fibers were produced by the edge-defined film-fed growth method. Fiber diameter was approximately 130 microns. Sol-gel derived ZrO_2 coatings were applied to the sapphire fibers by MSNW, Inc. (Escondido, CA). In previous studies, it was determined that porous coatings approximately 1 to 2 microns in thickness were equally or more effective in providing weak interfaces than coatings of greater thickness.⁴ Therefore, porous coatings, with a uniform thickness of approximately 1.5 microns and a submicron grain size were used to provide continuous fiber coverage (fig.1). In order to avoid any possible reactions between Y_2O_3 or other stabilizing agents and the sapphire fibers, all ZrO_2 coatings were unstabilized. It was also hoped that any microcracking that might occur as a result of phase changes within the ZrO_2 could enhance crack propagation around the fibers. To determine the effects of possible interactions between the fiber and coating that might occur with thermal exposure during composite processing or use, both coated and uncoated fibers were tensile tested both before and after heat treatment. Fibers were heat-treated in air at 1200, 1300, or 1400°C for 8 hours. Extended treatments of 24 or 100 hours at 1400°C were used to confirm the stability of the coated fibers. Approximately 15 to 20 fibers were tested for each heat treatment condition. The fiber gauge length for the room temperature tests was 0.635 cm (0.25 inches).

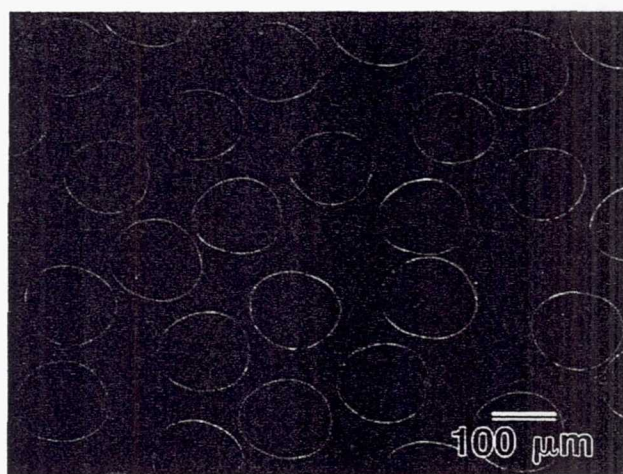
Figure 2. Cross-section of hot-pressed fiber reinforced composite showing random fiber distribution and uniform matrix density.

The composite microstructure, which can be observed in cross-section in Fig. 2, displayed uniform matrix density with a random fiber distribution. All matrix densities, regardless of processing conditions and heat treatment, ranged from 60 to 70% of theoretical density. The fiber volume percent was approximately 30 % for all of the unidirectionally aligned fiber composites. From the micrograph in figure 2, it is also important to note that the coating remains intact and continuous along the length of the fiber after processing. Previous work involving SnO_2 and Pt coatings in the same composite system resulted in nonuniform coatings after composite processing which led to securely bonded fibers and brittle composite behavior.^{6,7}

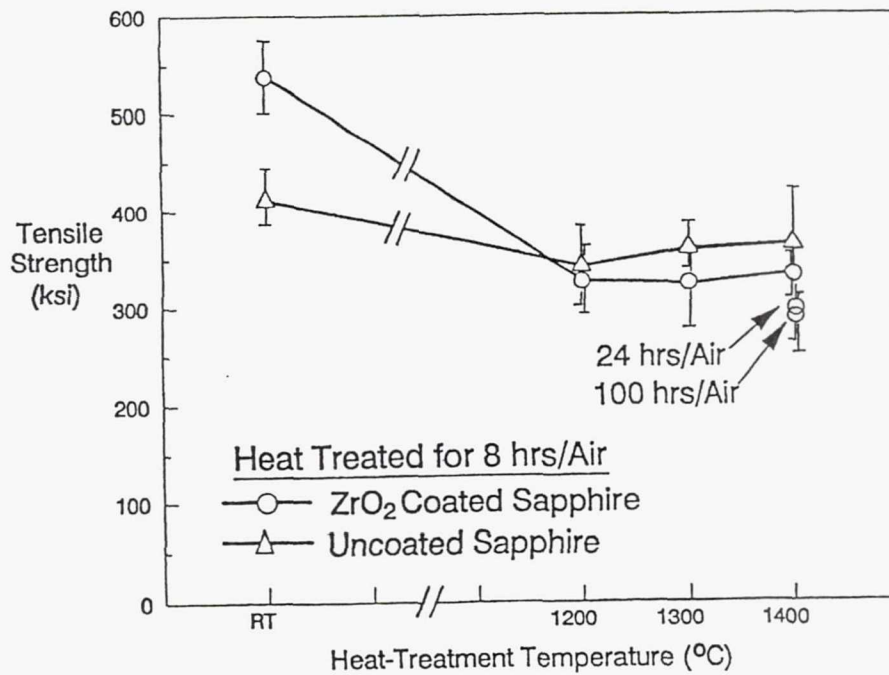
Figure 3. Effects of heat-treatment and ZrO_2 coatings on fiber tensile strengths.

The effects of the zirconia coatings on the on the room temperature tensile strengths of the fibers, both before and after additional heat treatment, can be seen in fig. 3. Each data point represents the average of 15 to 20 fiber tensile tests, with the error bars equal to \pm one standard deviation. From these data, there was no evidence of fiber degradation caused by the fiber coating process. After exposure to temperatures of 1200 to 1400°C, both uncoated and coated fibers maintain a residual strength of 300 to 375 ksi. With further heat treatment at 1400°C for 24 or 100 hours only a slight additional strength loss was observed for the coated fibers. The residual tensile strengths measured for the coated fibers are typical of the behavior of sapphire fibers under these conditions.^{6,8} Therefore the fiber coatings do not appear to be responsible for any further strength loss at temperatures that simulate those encountered during composite processing or use.

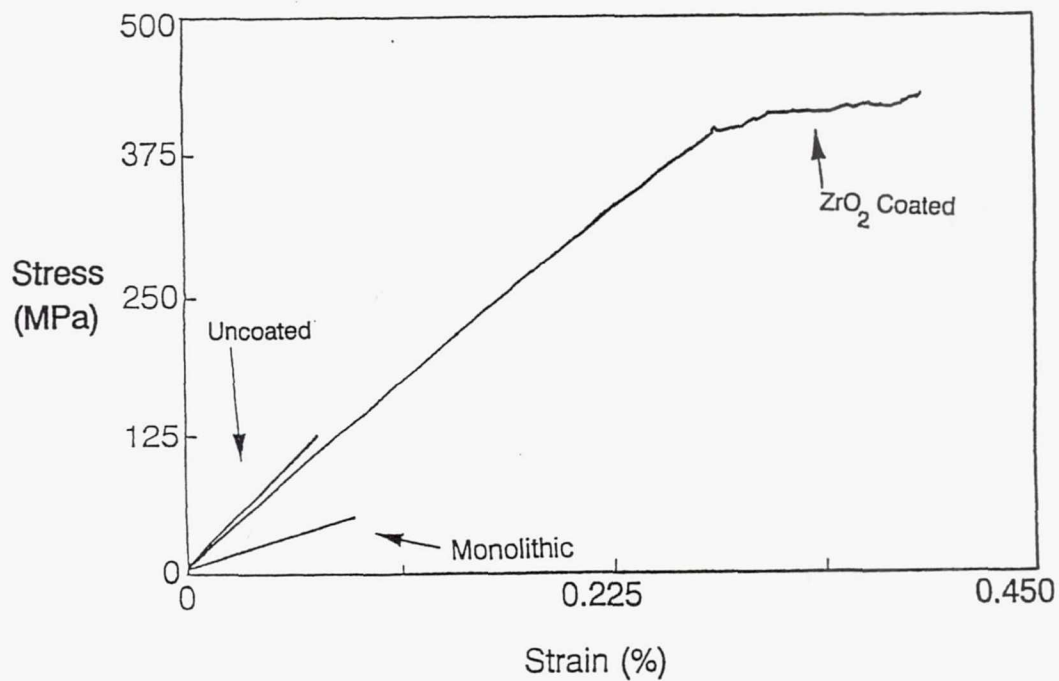
Figure 4. Stress vs. strain curves generated during tensile tests of monolithic Al_2O_3 , ZrO_2 coated and uncoated sapphire reinforced composites.

Tensile tests of both uncoated and coated fiber reinforced composites demonstrated the effectiveness of the ZrO_2 fiber coatings. Representative stress vs. strain curves generated from these tensile tests are displayed in figure 4. For comparison, monolithic alumina hot pressed under the same conditions and with the same tapes used for the composites was also tested. As expected, the porous monolithic material displays both low strength and strain to failure. The composite reinforced with the uncoated fibers benefits from the high modulus of the fibers and yields a much higher composite modulus, however, due to excessive bonding between the fiber and matrix, the ultimate strength is still quite low. The stress strain curves for the ZrO_2 coated fiber reinforced composites reveal the influence of the interfacial coating. The curves for these composites consistently extended well beyond those of the monolithic or uncoated fiber materials. Both ultimate strength and strain to failure are increased by the weaker interface provided by the ZrO_2 coating.

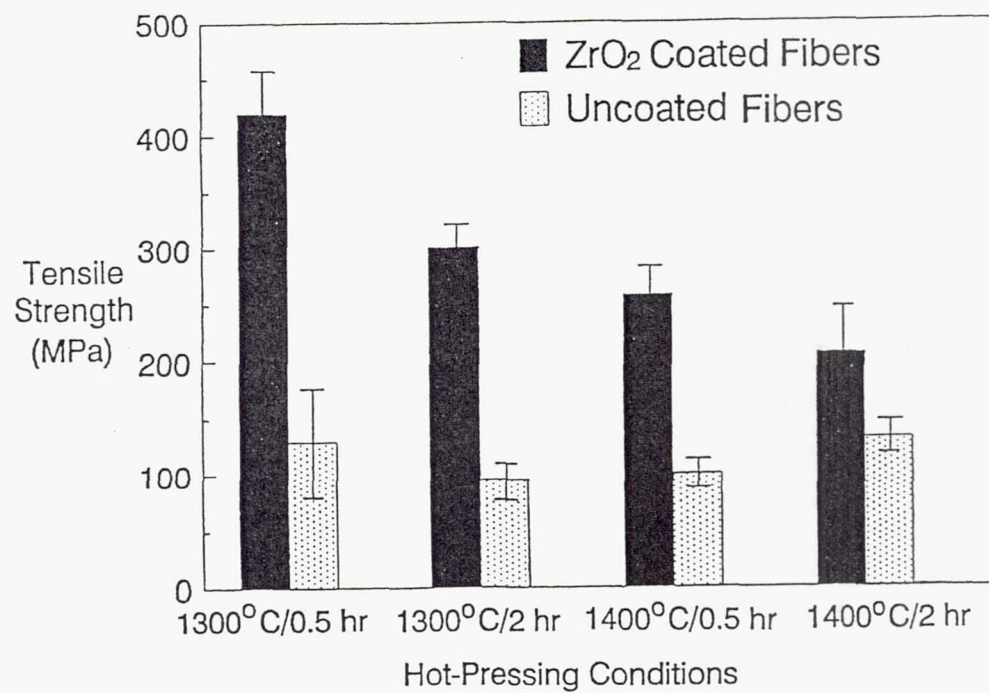
Figure 5. Effects of composite processing conditions and fiber coatings on ultimate composite tensile strengths.

The average ultimate tensile strengths of the coated and uncoated fiber reinforced composites are displayed graphically in figure 5. Each bar on this graph represents the average of 4 or more room temperature tests. Of the four sets of processing conditions studied, the lowest and least severe conditions yielded the highest strength composites. The ZrO_2 coated fiber reinforced composites processed at 1300°C for 0.5 hours possessed an average ultimate tensile strength of 421 ± 36 MPa. Uncoated fiber reinforced composites processed under the same conditions failed at a much lower strength of 130 ± 49 MPa due to strong bonding between fiber and matrix. The decrease in strength with increasing processing temperature and time is thought to be due to both increased bonding at the interface and also fiber strength loss which occurs with composite processing under pressure. The change in microstructure of the coating is responsible for both the increased bonding and the fiber strength loss. As the processing temperature and time are increased, the coating densifies and coarsens which leads to an interface that is too strong to allow failure within the coating. Also, the grain growth in the coating that

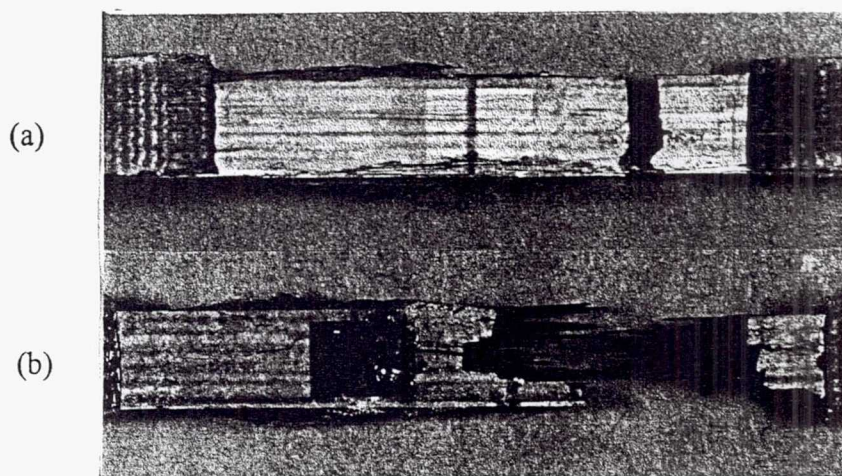
Figure 6. Composite tensile fracture samples with coated or uncoated fibers. (a)Uncoated fibers, (b)Coated fibers.

occurs during hot pressing and consolidation of the composite leads to a roughened fiber surface that mirrors the roughness of the ZrO_2 grains. This roughening of the fiber surface in addition to the coarsening of the coating leads to increased bonding at both the fiber and matrix interface. It is believed that this exaggerated roughening of the fiber surface, which has been observed and reported previously, leads to fiber strength loss.^{9,10} The composite tensile fracture samples, which are seen in figure 6, display the fiber pull-out that was observed in all coated fiber composites. Although fiber pull-out decreased slightly with increasing processing temperature and time, all composites reinforced with ZrO_2 coated fibers displayed some degree of pull-out after tensile testing. As expected, the uncoated fiber composites which failure at a much lower stress and strain, behaved in a brittle manner with no fiber pull-out.

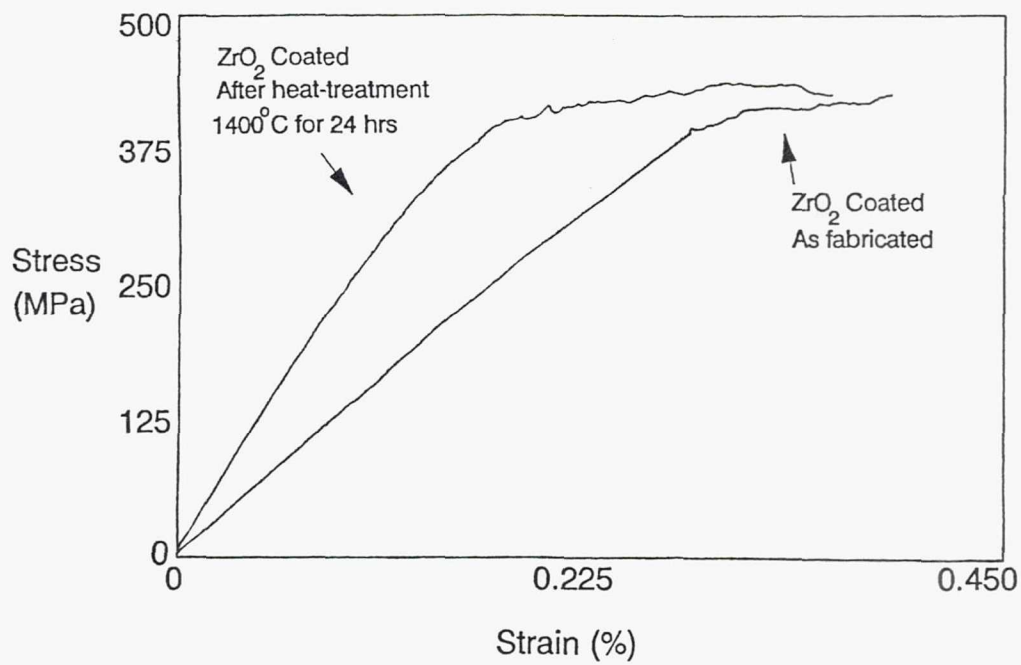
Figure 7. Stress vs. strain behavior for ZrO₂ coated fiber reinforced composites before and after heat-treatment.

Stress vs. strain behavior of the heat-treated composites can be seen in figure 7. Only the coated fiber composites processed at 1300°C for 0.5 hours received further heat treatment and evaluation. The composites continued to fail in a non-brittle manner with little change in ultimate strength, however a significant increase in modulus was observed. This increase may be explained in part by the increase in matrix density that occurred with further thermal exposure. However, the increase in density is so slight it is unlikely that it could be responsible for the total increase in modulus (refer to Table 1). Therefore it is believed that the increase in modulus is also related to the change in microstructure of the interfacial coating. Because the coating microstructure densifies and coarsens with heat-treatment, it is believed that the change in modulus is related to this localized densification around the fibers. Although the interface becomes more rigid, the coating is still capable of limiting fiber/matrix bonding and maintaining composite strength after heat-treatment to 1400°C for 24 hours. The average ultimate tensile strengths measured for the heat-treated composites are displayed in figure 8. After heat-treatment at 1400°C for 8 or 24 hours, the coated fiber composites retained 95 or 87% of their strength, respectively. This

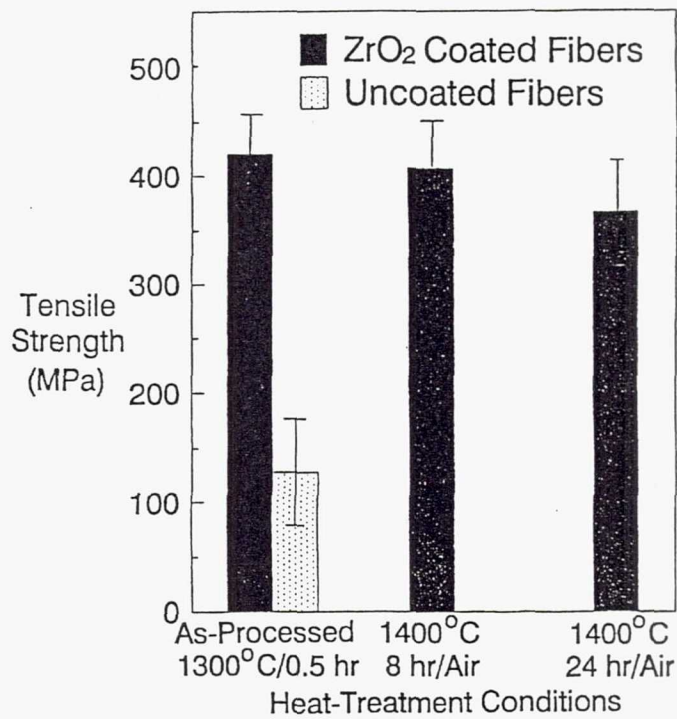
Figure 8. Ultimate composite tensile strengths after heat-treatment.

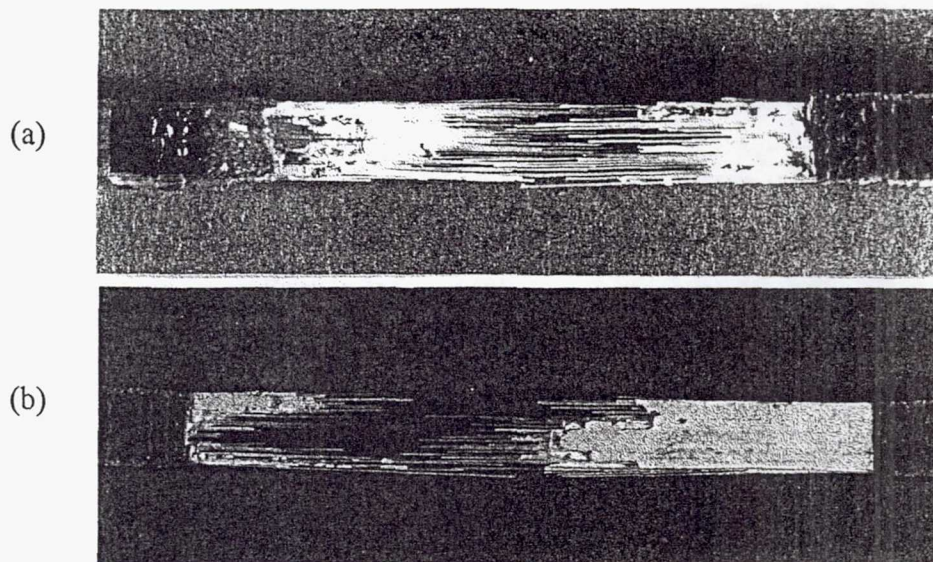
Figure 9. Coated fiber composite fracture samples after heat-treatment to 1400°C for (a) 8 hours or (b) 24 hours.

strength retention indicates that exposure to expected use temperatures without the application of pressure will not severely degrade the fiber and composite strengths. The heat-treated samples when tested in tension continued to display considerable fiber pull-out (fig. 9).

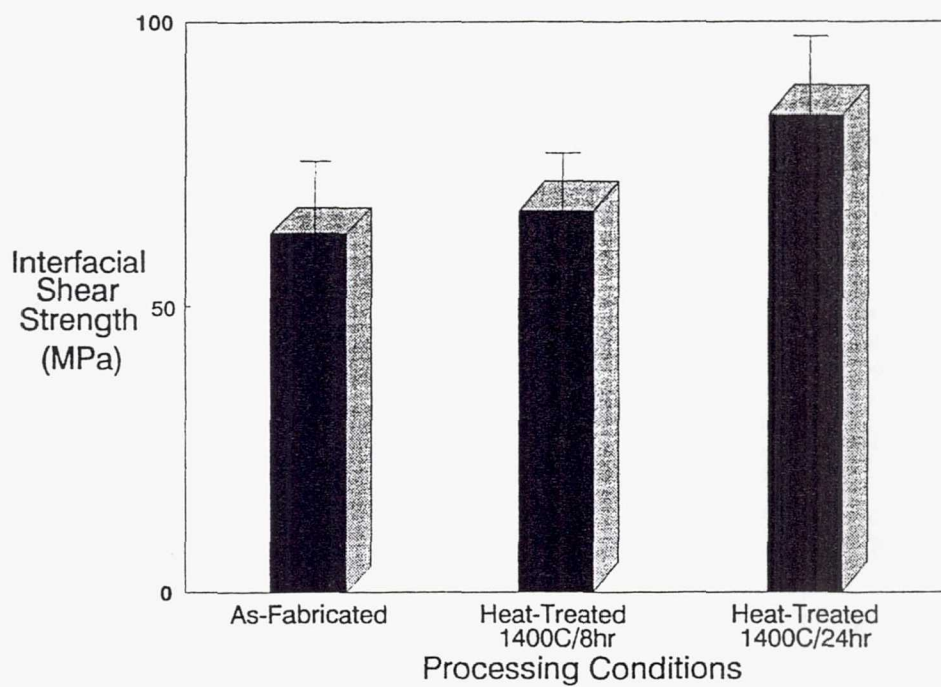
Figure 10. Effects of heat-treatment on the interfacial shear stress of ZrO_2 coated fiber reinforced composites.

The interfacial shear stresses (ISS) for only the ZrO_2 coated fiber reinforced composites are displayed in figure 10. Fiber push-out tests of uncoated fiber reinforced composites were not possible due to equipment failure or excessive cracking of the matrix and fiber caused by the extremely high loads needed to shear the strong fiber/matrix bond. Each bar in this graph represents the average of 15 to 20 fibers pushed out of the matrix. With coated fibers, the as-fabricated composite yielded a relatively low ISS of 58 MPa. After exposure to 1400°C for 8 or 24 hours the ISS increased to 66 and 83 MPa, respectively. It is believed that this increase is due to the coarsening and densification of coating microstructure that was observed in the SEM.

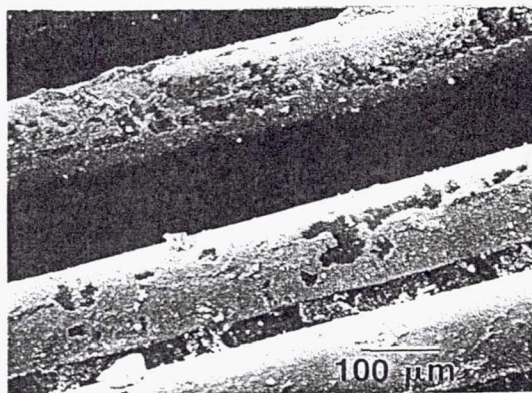
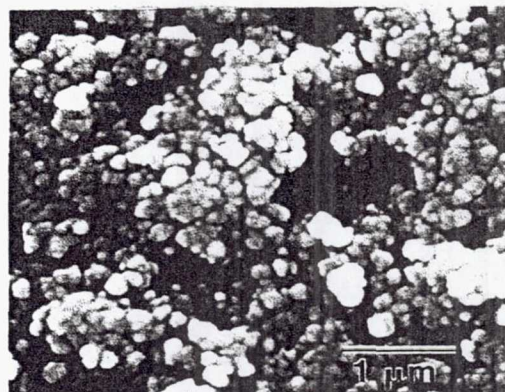
Fiber pull out from tensile test

Residual ZrO_2 on pulled out fiber

Figure 11. Micrographs of ZrO_2 coated fibers pulled out of the matrix during composite tensile test. Composite was hot-pressed 1300°C for 0.5 hours.

This change in the coating microstructure can be seen in the micrographs in figures 11 and 12. Examination of the fracture surfaces from composites hot-pressed at 1300°C and then tensile tested at room temperature revealed a substantial amount of residual ZrO_2 remaining on the fibers which pulled out of the matrix (fig. 11.a). Closer inspection of the darker areas on the pulled out fiber reveal more fine grained ZrO_2 adhering to the fiber surface (fig. 11.b), thus indicating that interfacial failure can occur within the coating layer. In general, the lowest ISS was measured when interfacial failure occurred within the coating layer rather than at the coating/matrix or coating/fiber interface. There was no evidence of pitting or roughening of the fiber surface after the initial processing at 1300°C for 0.5 hours. The change in microstructure of the interfacial coating after heat treatment to 1400°C for 24 hours (fig. 12) is consistent with the increase in the interfacial shear stress. In these composites the interfacial failure occurs at either the fiber/coating

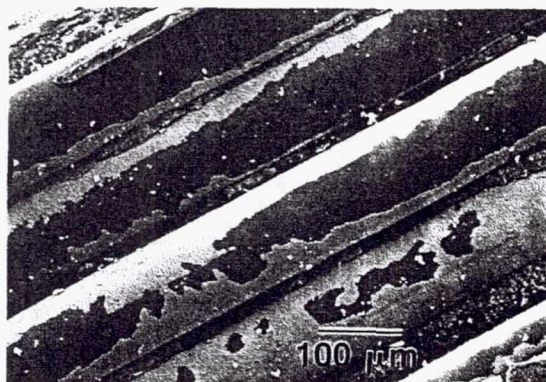
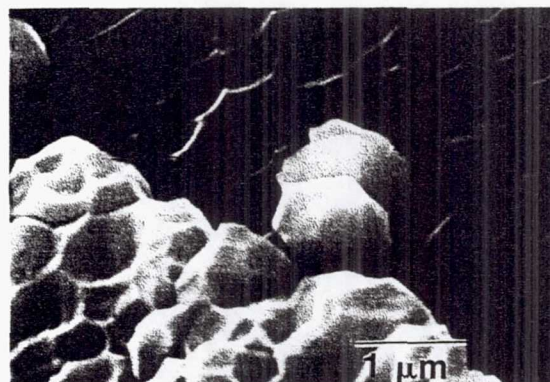
Fiber pull out from tensile test

Residual ZrO_2 on pulled out fiber

Figure 12. Micrographs of ZrO_2 coated fibers pulled out of the matrix during composite tensile test. Composite was originally hot-pressed at 1300°C for 0.5 hours then heat-treated at 1400°C for 24 hours.

interface or the coating/matrix interface, but not within the coating itself. The coating has coarsened considerably thus causing severe roughening of the fiber surface. Other researchers have shown that interfacial roughness has a significant influence on interfacial debonding in brittle matrix composites.^{11,12} The increased coating density and grain size combined with the roughening of the fiber surface result in greater difficulty in debonding the fibers.
